FACILITY CONDITION ASSESSMENT

FACILITY CONDITION ASSESSMENT
OF
MAINTENANCE AND ADMINISTRATION FACILITY
130 WEST GRIMES LANE
BLOOMINGTON, INDIANA 47403

February 11, 2019

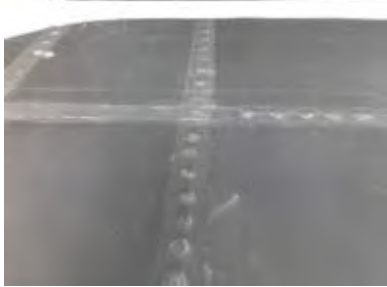
Single-Ply EPDM Membrane
Garage Roof

Roof in Poor condition.

Roof leaks in several locations - AssetCALC ID: 1159085

Uniformat Code: B3011
Recommendation: **Replace in 2019**

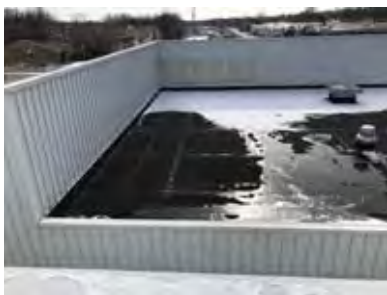
Single-Ply EPDM Membrane
Administration & Operations Building Roof

Roof in Poor condition.

Roof has several small active leaks and has exceeded expected useful life. - AssetCALC ID: 1159068

Uniformat Code: B3011
Recommendation: **Replace in 2019**

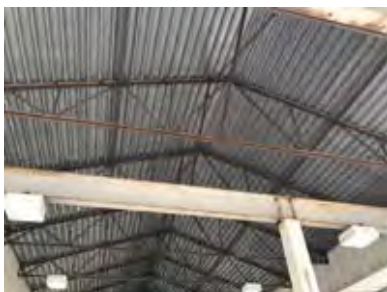
Metal
Fuel Island Throughout building

Structural Flooring/Decking in Poor condition.

Metal support structure has rust in many places, should be refinished to protect from further rust damage. - AssetCALC ID: 1159063

Uniformat Code: B1012
Recommendation: **Refinish in 2020**

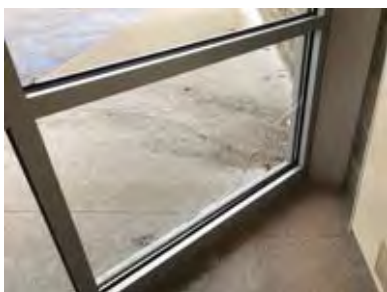
SF
Administration & Operations Building 100
Vestibule

Window in Poor condition.

Cracked pane at entrance vestibule. - AssetCALC ID: 1157833

Uniformat Code: B2021
Recommendation: **Replace in 2019**

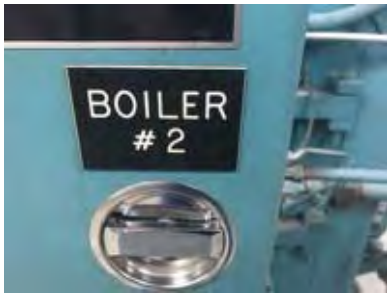
2500 MBH
Garage Boiler room

Boiler in Poor condition.

Boiler #2 scheduled for replacement summer 2019. - AssetCALC ID: 1159082

Uniformat Code: D3021
Recommendation: **Replace in 2020**

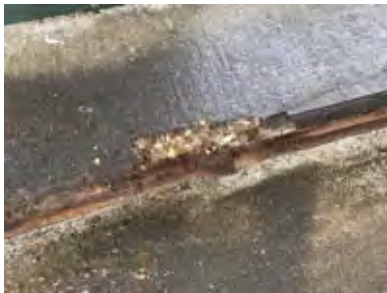
Concrete Curb & Gutter
Fuel Island Throughout building

Roadways in Poor condition.

Metal edges of curbs is rusted through and failed in many locations, will need to be replaced throughout. - AssetCALC ID: 1159062

Uniformat Code: G2012
Recommendation: **Replace in 2020**

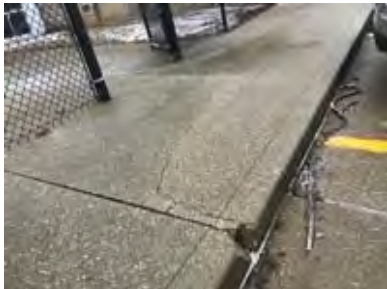
Sidewalk, Concrete Large Areas
Site Site- Side Parking

Pedestrian Pavement in Poor condition.

Isolated areas of concrete sidewalks exhibiting cracks. - AssetCALC ID: 1158962

Uniformat Code: G2031
Recommendation: **Replace in 2019**

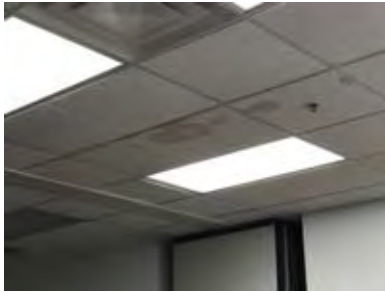
Suspended Acoustical Tile (ACT)
Administration & Operations Building
Conference & Copy Room

Interior Ceiling Finish in Poor condition.

Roof leaks have damaged areas of the ceiling in the conference and copy rooms - AssetCALC ID: 1157260

Uniformat Code: C3032
Recommendation: **Replace in 2020**

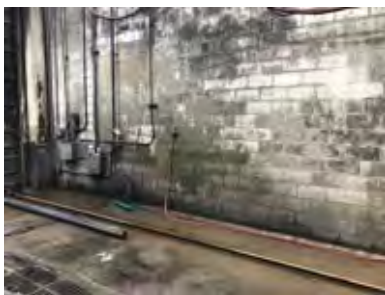
Concrete/Masonry
Garage Bus Wash

Interior Wall Finish in Poor condition.

Paint has worn away on the walls and needs to be redone. - AssetCALC ID: 1159137

Uniformat Code: C3012
Recommendation: **Prep & Paint in 2019**

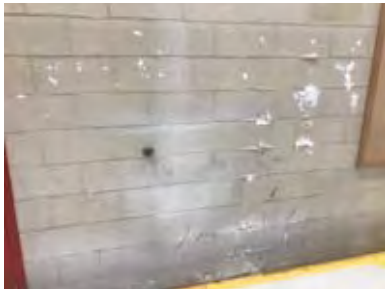
Concrete/Masonry
Garage Vehicle Service Bays

Interior Wall Finish in Poor condition.

Paint peeling in vehicle service area - AssetCALC ID: 1159157

Uniformat Code: C3012
Recommendation: **Prep & Paint in 2020**

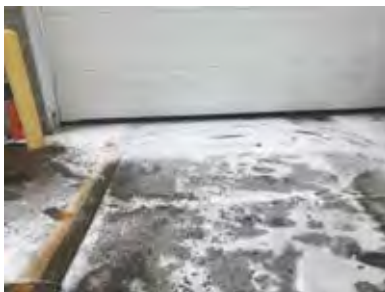
Concrete Pavement
Site Site - Bus Parking

Parking Lots in Poor condition.

Large areas of concrete paving exhibiting cracks, depressions and isolated areas of exposed reinforcing bars. - AssetCALC ID: 1157845

Uniformat Code:
Recommendation: **Replace in 2020**

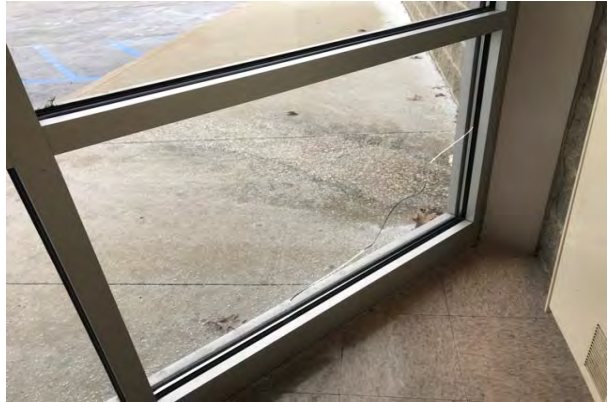
#26	WINDOW, ALUMINUM DOUBLE-GLAZED, CRACKED PANE
-----	--

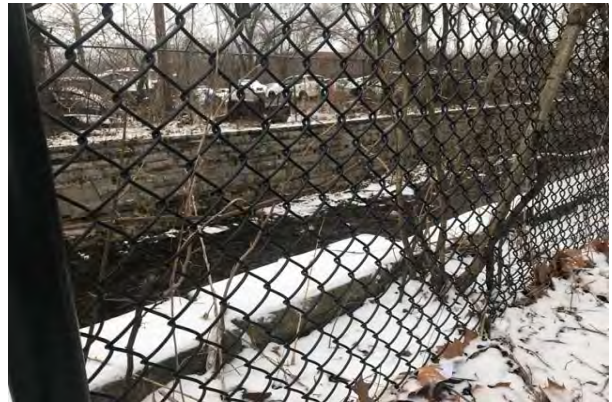
#4	FENCES AND GATES, CHAIN LINK, WITH VEGETATIVE GROWTH
----	--

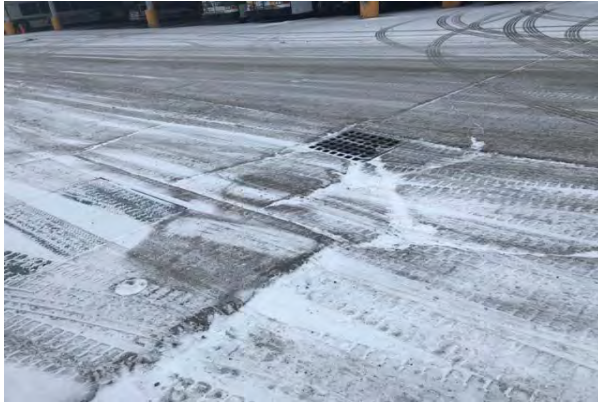
#7	PARKING LOTS, CONCRETE PAVEMENT, LARGE CRACKS IN DRIVE AISLES
----	---

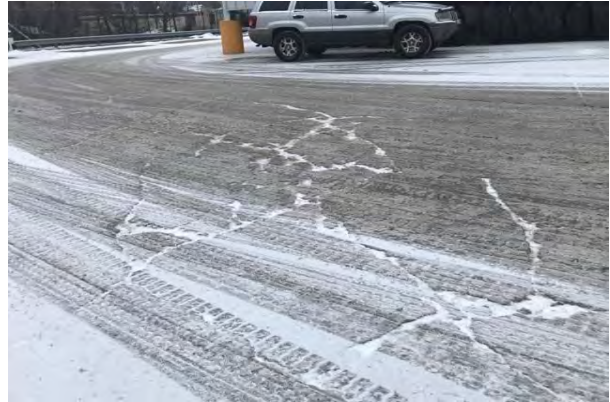
#8	PARKING LOTS, CONCRETE PAVEMENT, LARGE CRACKS IN DRIVE AISLES
----	---

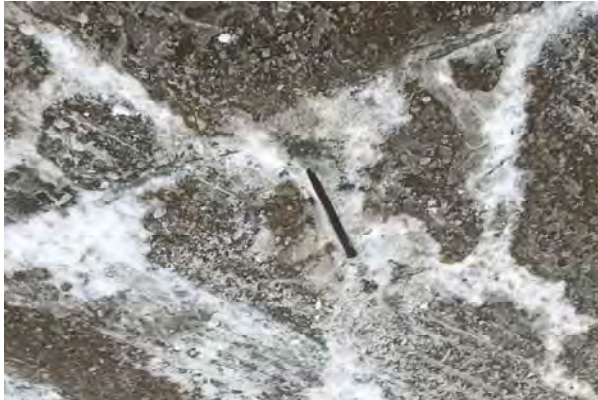
#9	PARKING LOTS, CONCRETE PAVEMENT, EXPOSED REINFORCING BAR
----	--

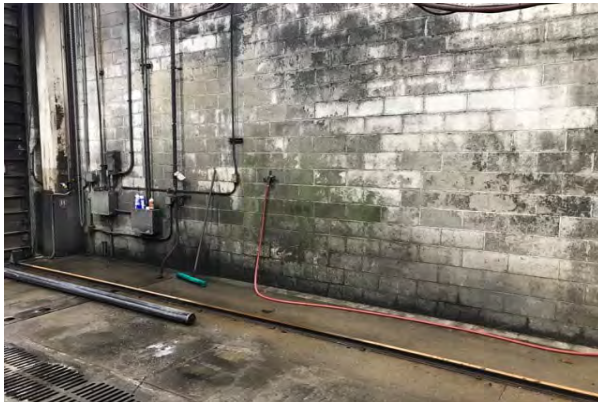
#33	DAMAGED WALL FINISH IN BUS WASHING AREA
-----	---

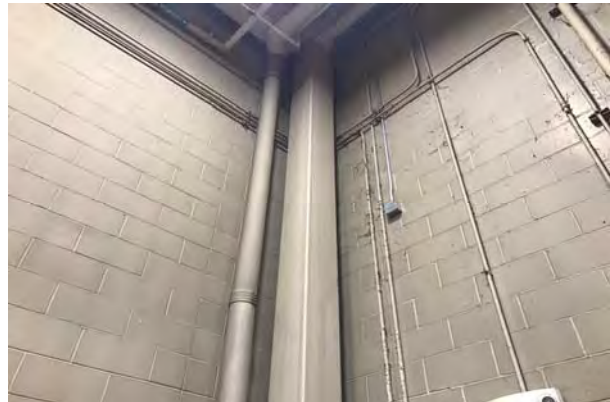
#34	BUILDING STRUCTURE WHICH SHOWS WATER STAINS FROM ROOF LEAK
-----	--

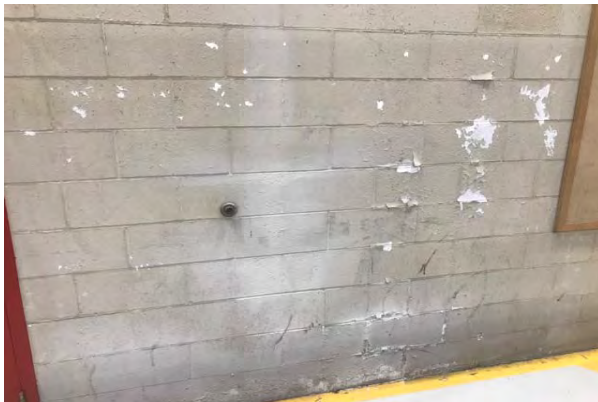
#35	WALL WITH PEELING AND FLAKING PAINT IN VEHICLE SERVICE AREA
-----	---

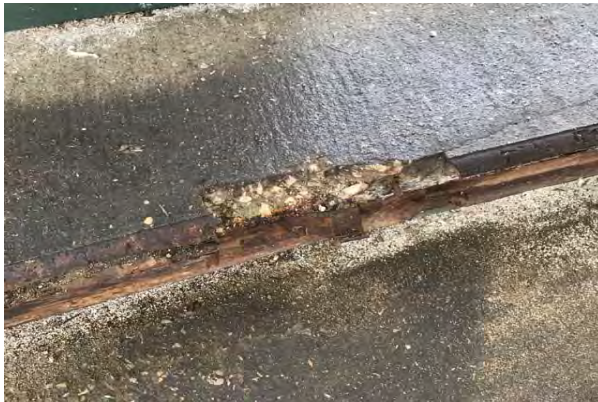
#9	CURB DETERIORATION
----	--------------------

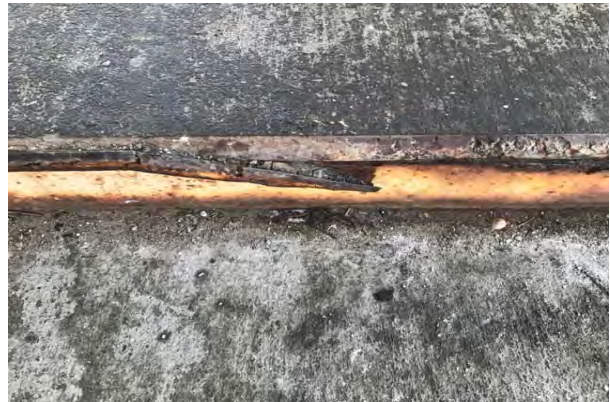
#10	CURB DETERIORATION
-----	--------------------

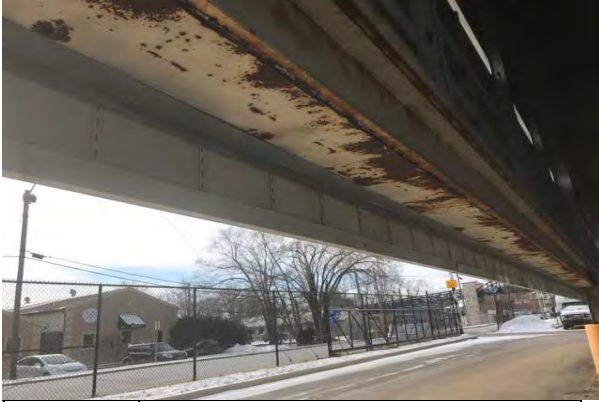
#7	STRUCTURAL FRAMING, METAL EXHIBITING CORROSION
----	--

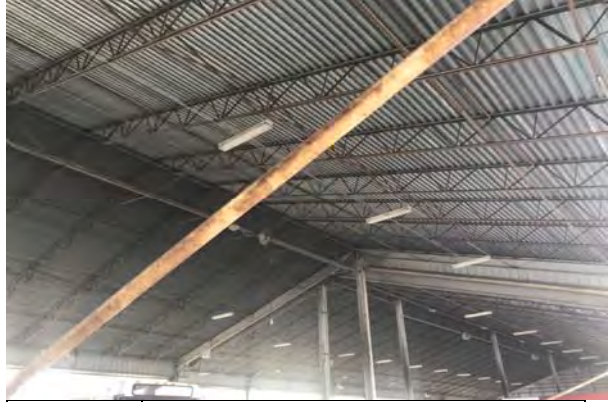
#8	STRUCTURAL FRAMING, METAL EXHIBITING CORROSION
----	--
