FACILITY CONDITION ASSESSMENT

FACILITY CONDITION ASSESSMENT
OF
MAINTENANCE AND ADMINISTRATION FACILITY
130 WEST GRIMES LANE
BLOOMINGTON, INDIANA 47403

February 11, 2019

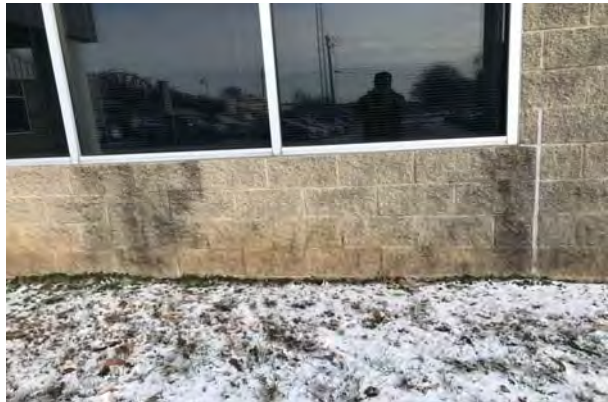
#22	EXTERIOR WALL, CONCRETE/MASONRY (CMU), REQUIRES CLEANING
-----	--

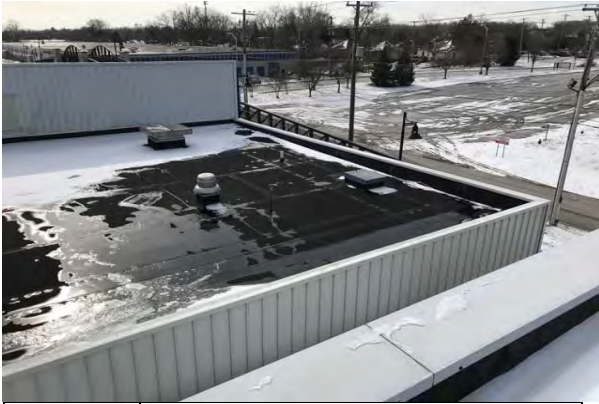
#30	ROOF, METAL
-----	-------------

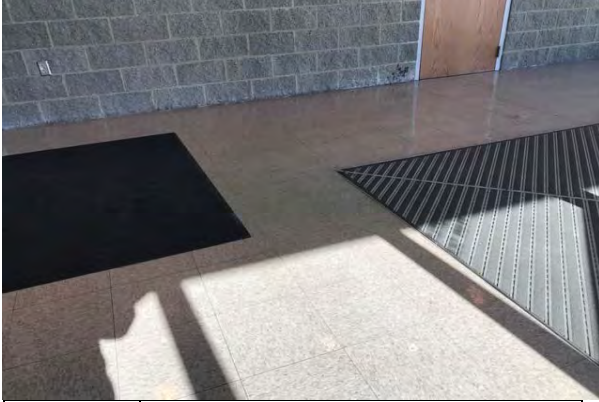
#36	INTERIOR FLOOR FINISH, CERAMIC TILE
-----	-------------------------------------

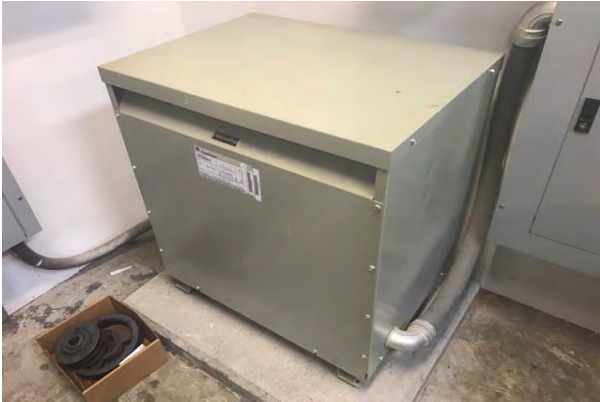
#54	SECONDARY TRANSFORMER, DRY
-----	----------------------------

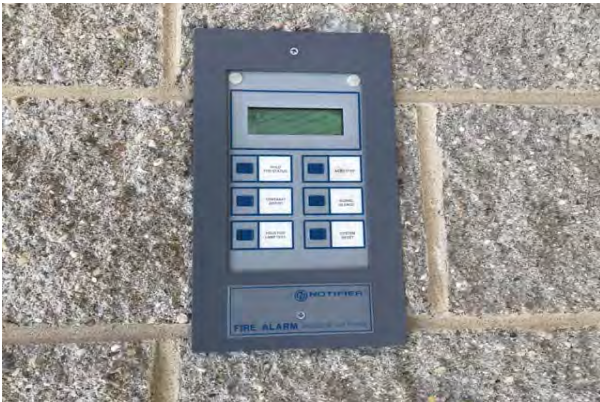
#56	FIRE ALARM CONTROL PANEL
-----	--------------------------

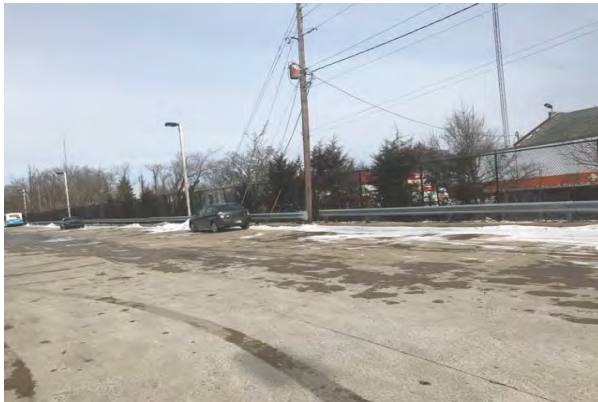
#2	FENCES AND GATES, METAL TUBE
----	------------------------------

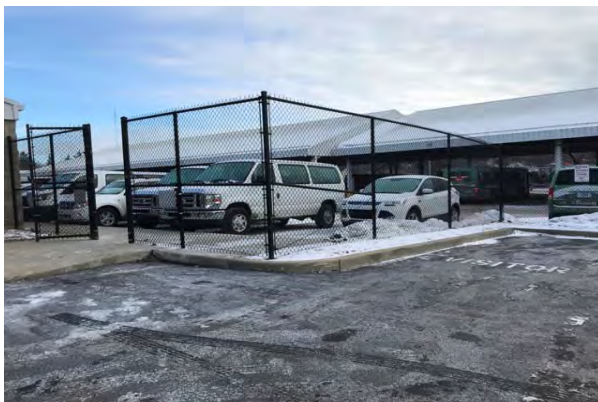
#4	FENCES AND GATES, CHAIN LINK, WITH VEGETATIVE GROWTH
----	--

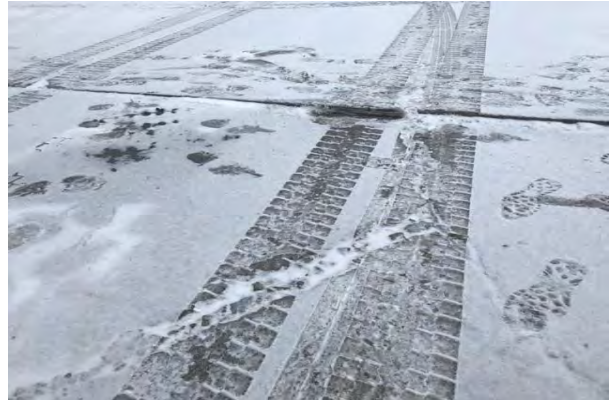
#9	PARKING LOTS, CONCRETE PAVEMENT, EXPOSED REINFORCING BAR
----	--

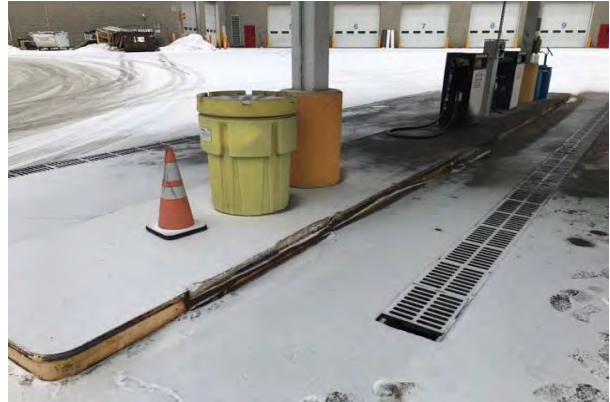
#8	DIESEL FUEL SIDE
----	------------------
