FACILITY CONDITION ASSESSMENT

FACILITY CONDITION ASSESSMENT
OF
MAINTENANCE AND ADMINISTRATION FACILITY
130 WEST GRIMES LANE
BLOOMINGTON, INDIANA 47403

February 11, 2019

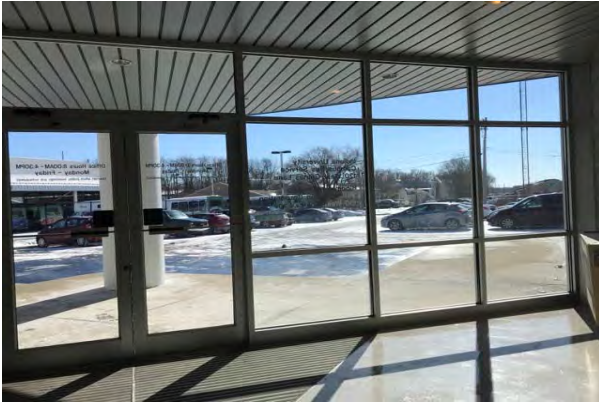
#7	VESTIBULE
----	-----------

Cracked pane at entrance vestibule. - AssetCALC ID: 1157833

Uniformat Code: B2021
Recommendation: **Replace in 2019**

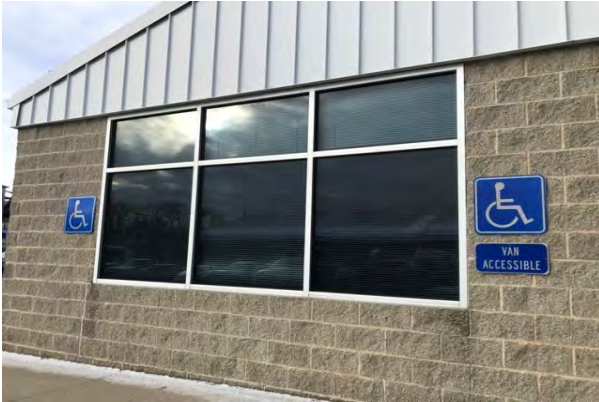
#24	WINDOW, ALUMINUM DOUBLE-GLAZED
-----	--------------------------------

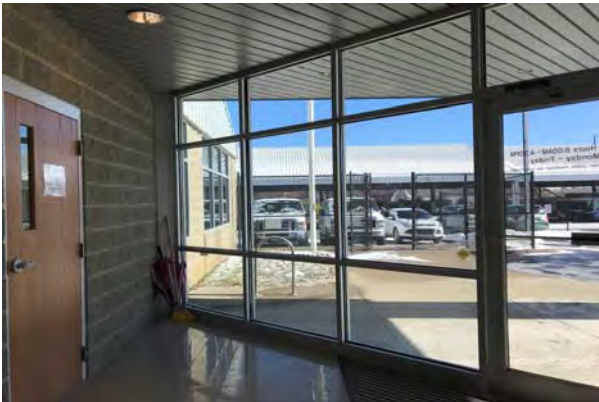
#26	WINDOW, ALUMINUM DOUBLE-GLAZED, CRACKED PANE
-----	--

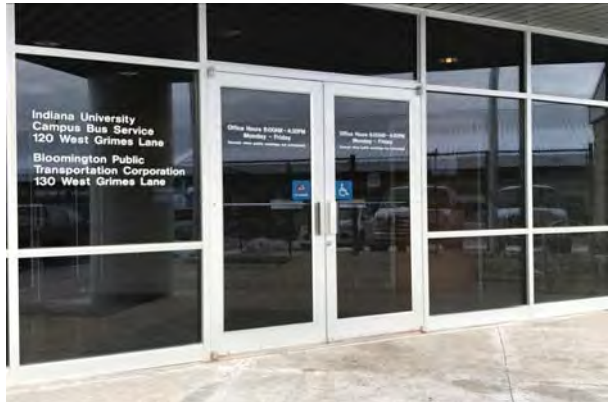
#27	STOREFRONT, METAL-FRAMED WINDOWS W/OUT DOOR(S)
-----	--

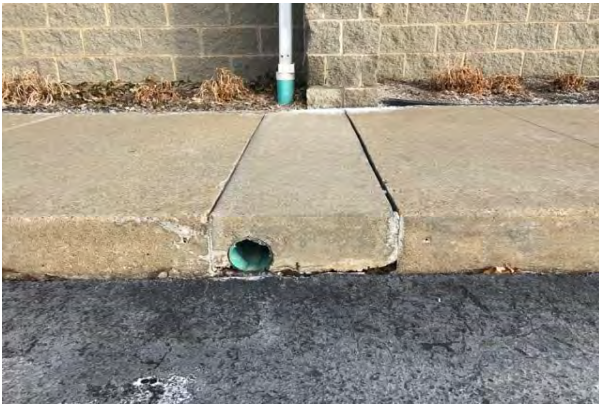
#32	GUTTERS & DOWNSPOUTS, ALUMINUM W/ FITTINGS
-----	--

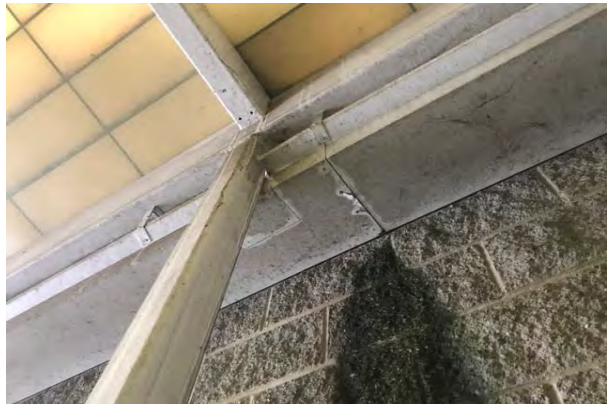
#33	GUTTERS & DOWNSPOUTS, ALUMINUM W/ FITTINGS
-----	--

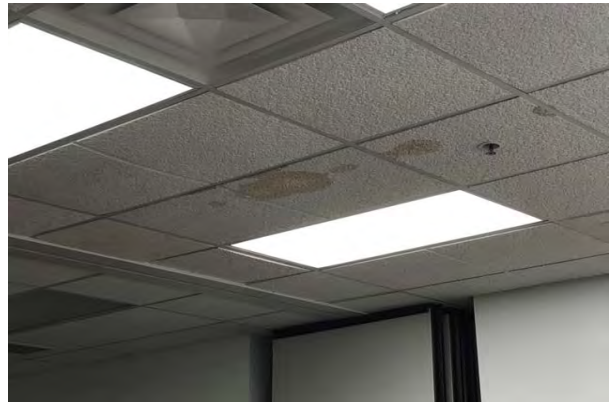
#39 INTERIOR CEILING FINISH, PAINTED DRYWALL

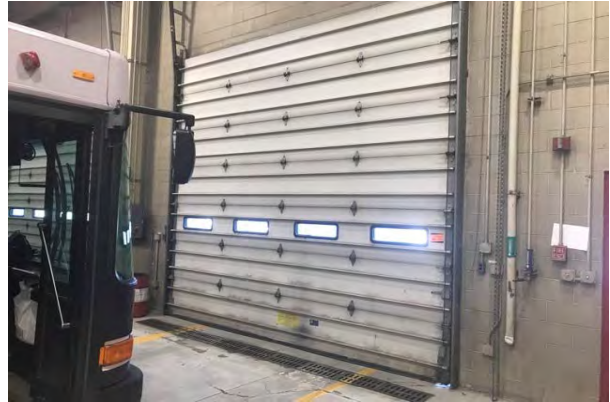
#32	OVERHEAD DOOR
-----	---------------

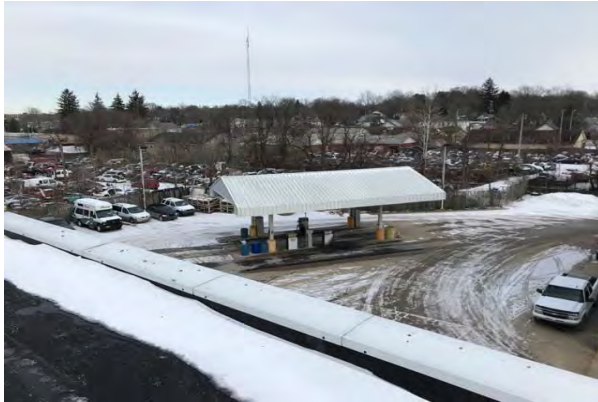
#1	EXTERIOR VIEW
----	---------------

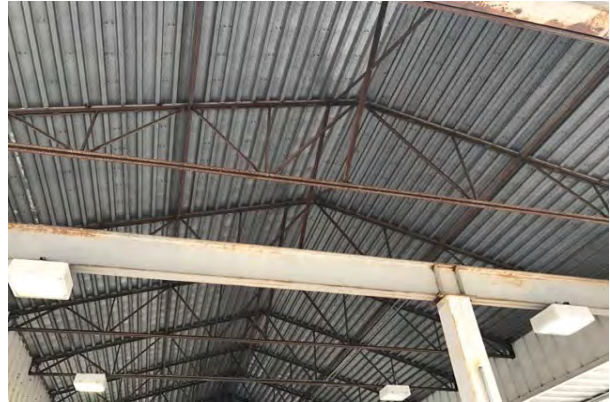
#2	BUILDING STRUCTURE
----	--------------------

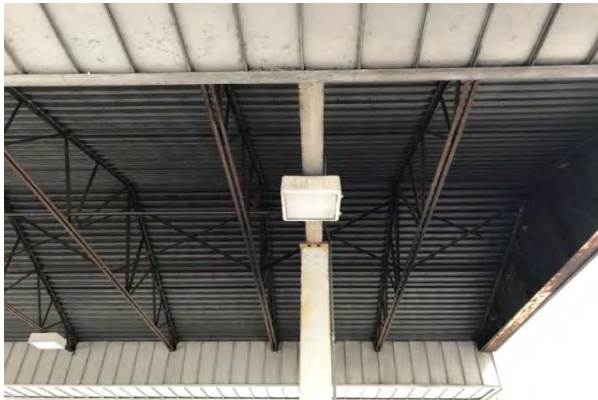
#3	LIGHTING FIXTURE
----	------------------

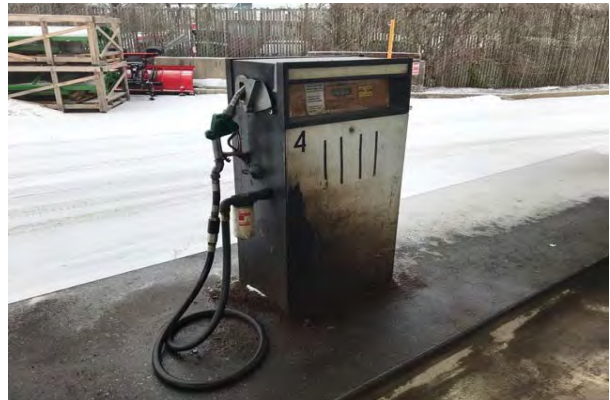
#4	DIESEL FUEL PUMP
----	------------------

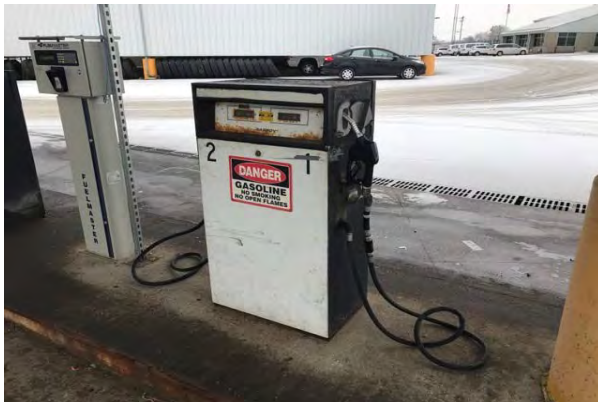
#5	UNLEADED GASOLINE PUMP
----	------------------------

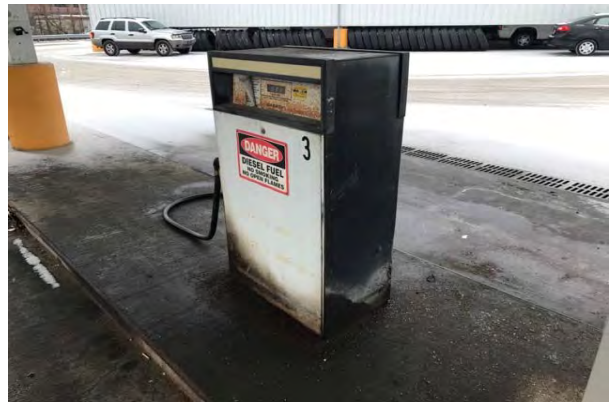
#6	DIESEL FUEL PUMP
----	------------------

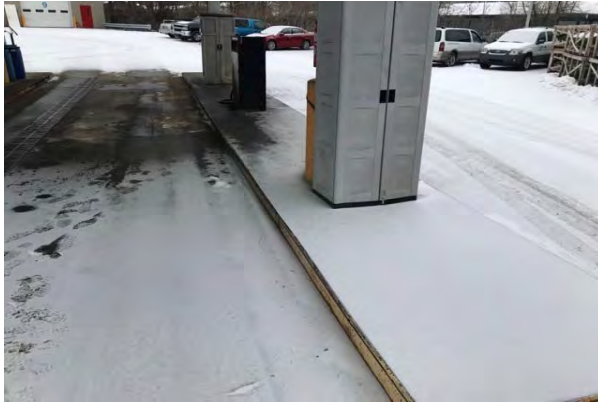
#7	UNLEADED FUEL SIDE
----	--------------------
